September 1945 as
Memorandum Report E5I27a

**EFFECT OF MAXIMUM CRUISE-POWER OPERATION AT ULTRA-LEAN
MIXTURE AND INCREASED SPARK ADVANCE ON THE MECHANICAL
CONDITION OF CYLINDER COMPONENTS**

By Herbert B. Harris, Robert T. Duffy, and Robert D. Erwin, Jr.

Aircraft Engine Research Laboratory
Cleveland, Ohio

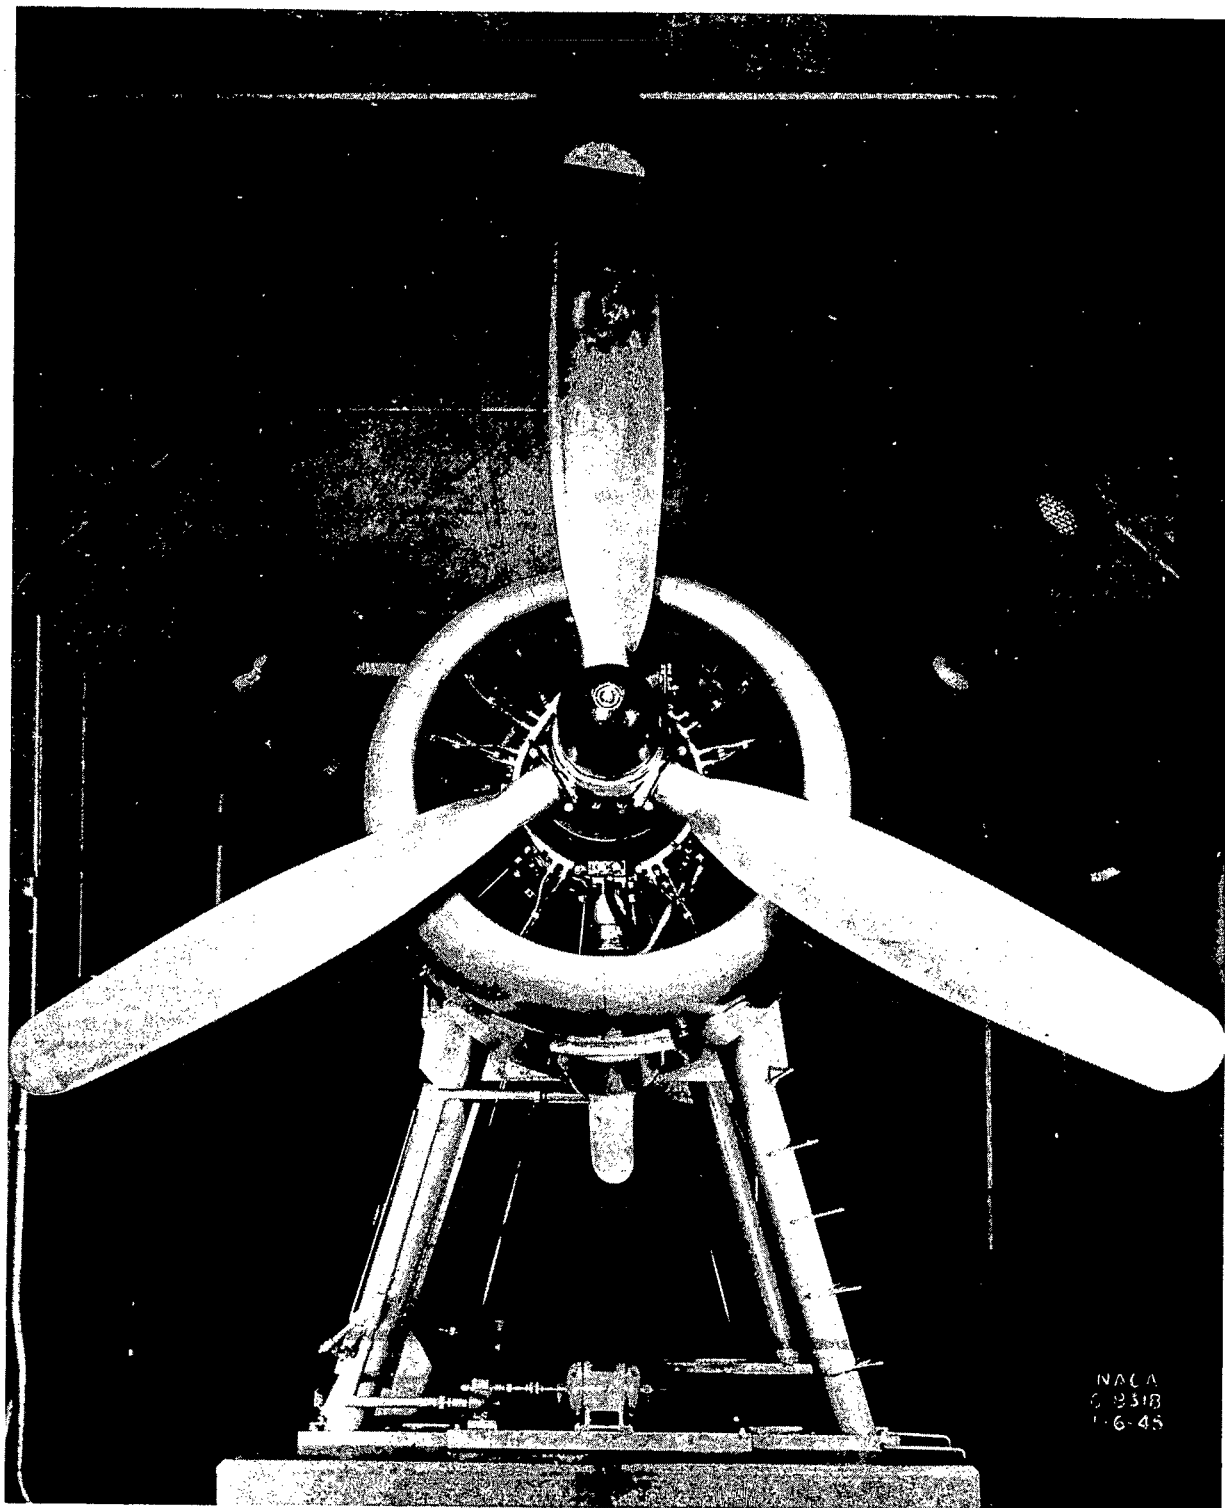
Figure 1. - Nine-cylinder air-cooled radial engine test setup for continuous 50-hour multicylinder-engine test.

The engine was mounted on a multicylinder-engine test stand as shown in figure 1. The power was absorbed by a three-blade flight propeller and engine speed was controlled by a hydromatic constant-speed governor. Brake mean effective pressure was indicated by a hydraulic torquemeter, which was integral with the propeller reduction gearing. Combustion air was supplied by an external blower with an aircraft filter element on its intake. The combustion-air flow was measured by the method described in reference 6 (uncompensated metering-suction differential). The carburetor with the inlet elbow

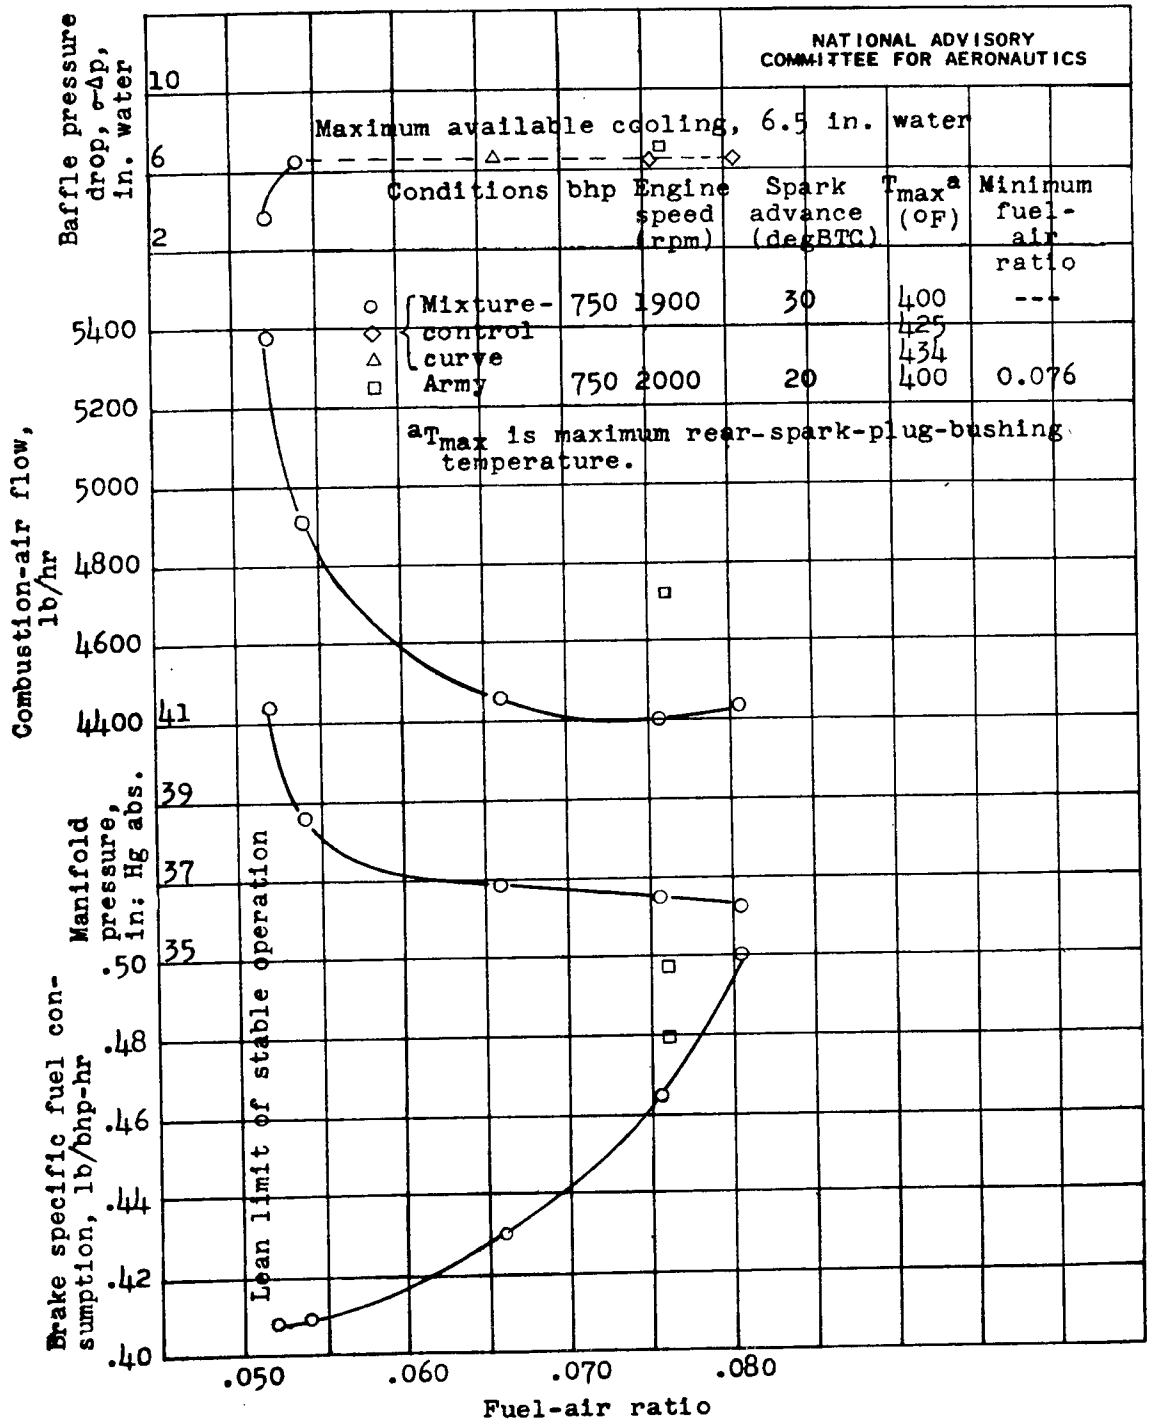
Figure 2. - Mixture-control curve for nine-cylinder air-cooled radial engine tested. Values added for the same engine operating at the conditions recommended in reference 1.

Mixture-control curve. - The optimum fuel-air ratio for the power, the speed, and the spark advance chosen was determined by the constant-power mixture-control curve (fig. 2), which was run as the first part of this test. This curve shows decreasing brake specific fuel consumption up to the lean limit for stable engine operation, fuel-air ratio of 0.052, for these conditions. The brake specific fuel consumption for this engine operating at 750 brake horsepower

at the conditions recommended in reference 1 was determined and is plotted on figure 2 for comparison. The difference between the specific fuel consumption (at the conditions of reference 1) and that for the conditions of this test indicates a fuel saving of 14.6 percent for the same power output neglecting the difference in cooling-air drag horsepower between the two conditions. The saving taking into account the difference in cooling-air drag horsepower (cooled-power basis) was calculated according to the method of reference 2 and found to be 16.8 percent.

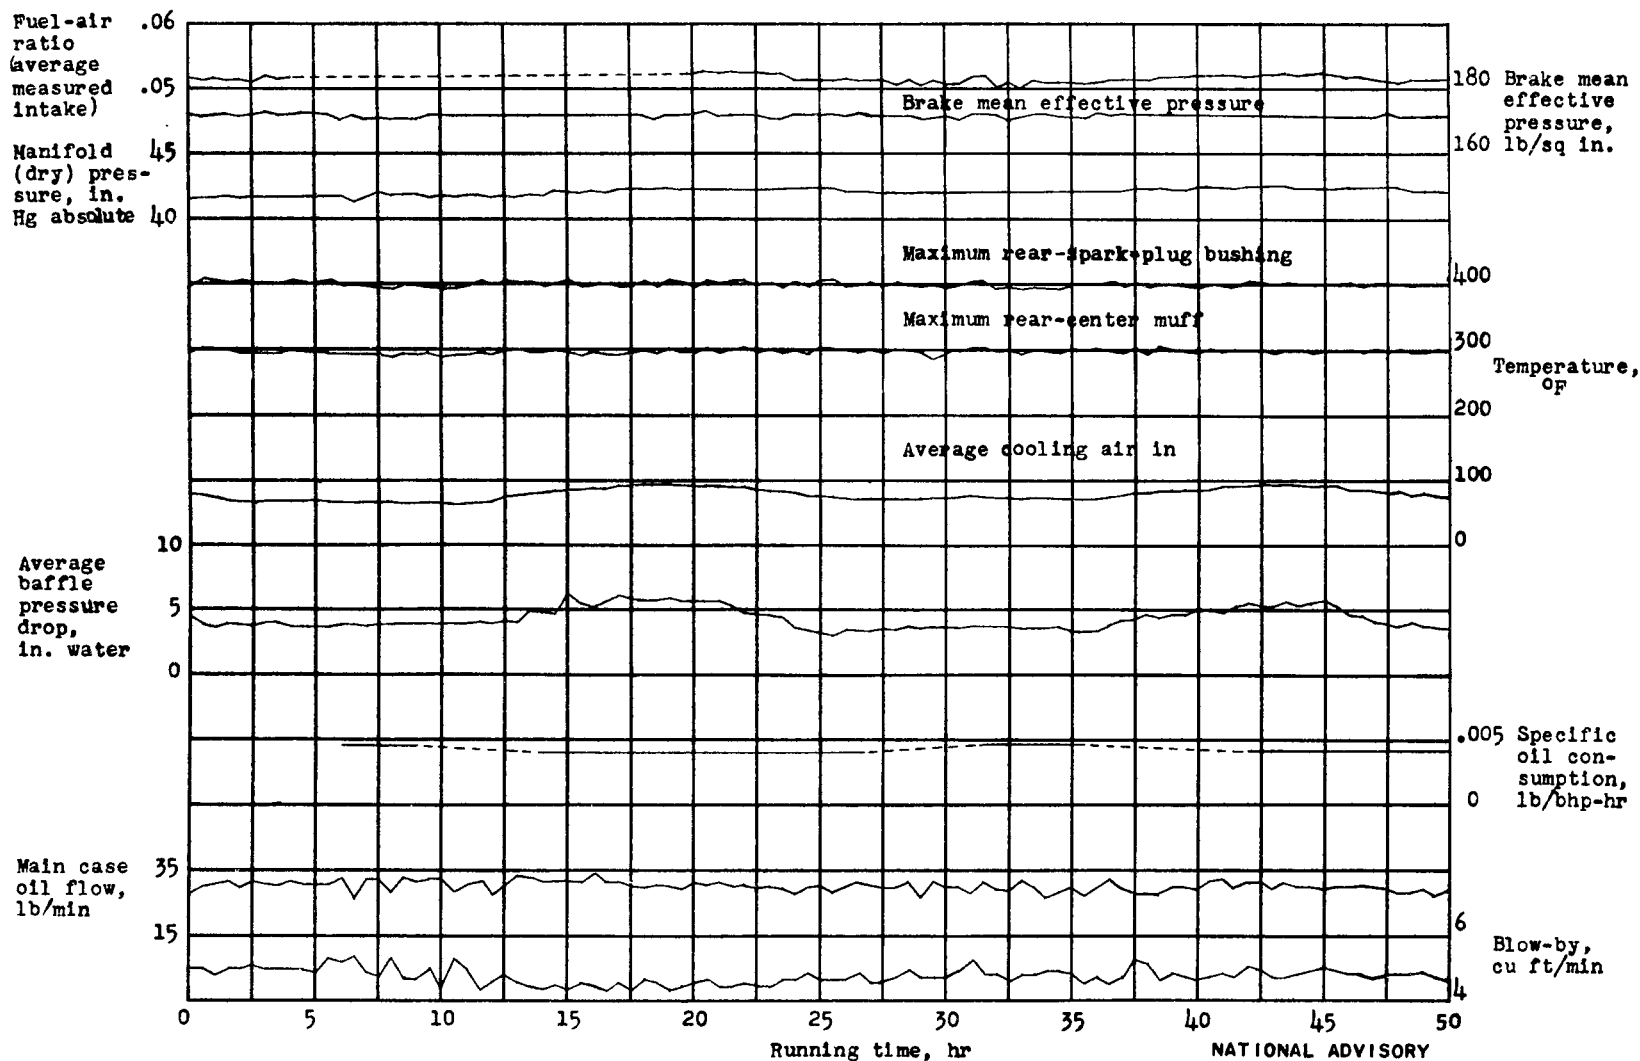
Figure 4. - Graphic log of 50-hour test of nine-cylinder air-cooled radial engine. Brake horsepower, 750; engine speed, 1900 rpm; brake mean effective pressure, 172 pounds per square inch; fuel-air ratio, 0.052; spark advance, 30° B.T.C.

Graphic log of test. - A graphic log of the test, which was run continuously to avoid the corrosion caused by shutdown and the excessive wear of starting, is shown in figure 4. During the entire test, the fuel-air ratio as determined by measured intake was closely checked by Orsat analysis of the oxidized exhaust gas. Because of a defective manometer line, the values of combustion-air flow and consequently fuel-air ratio by measured intake were faulty for the period of 4 to 20 hours of the test. Orsat analysis, however, showed that the maximum variation in fuel-air ratio for this period was

within the limits of variation for the entire test. Therefore this portion of the fuel-air-ratio curve is indicated as a straight dashed line on the graphic log. Specific oil consumption showed no tendency to rise during the test and was well below the manufacturer's maximum allowable specific oil consumption of 0.020 pound per brake horsepower hour for 1900 rpm cruise operation (reference 8). Blow-by also showed no tendency to rise during the test. No indication of knock was ever present.

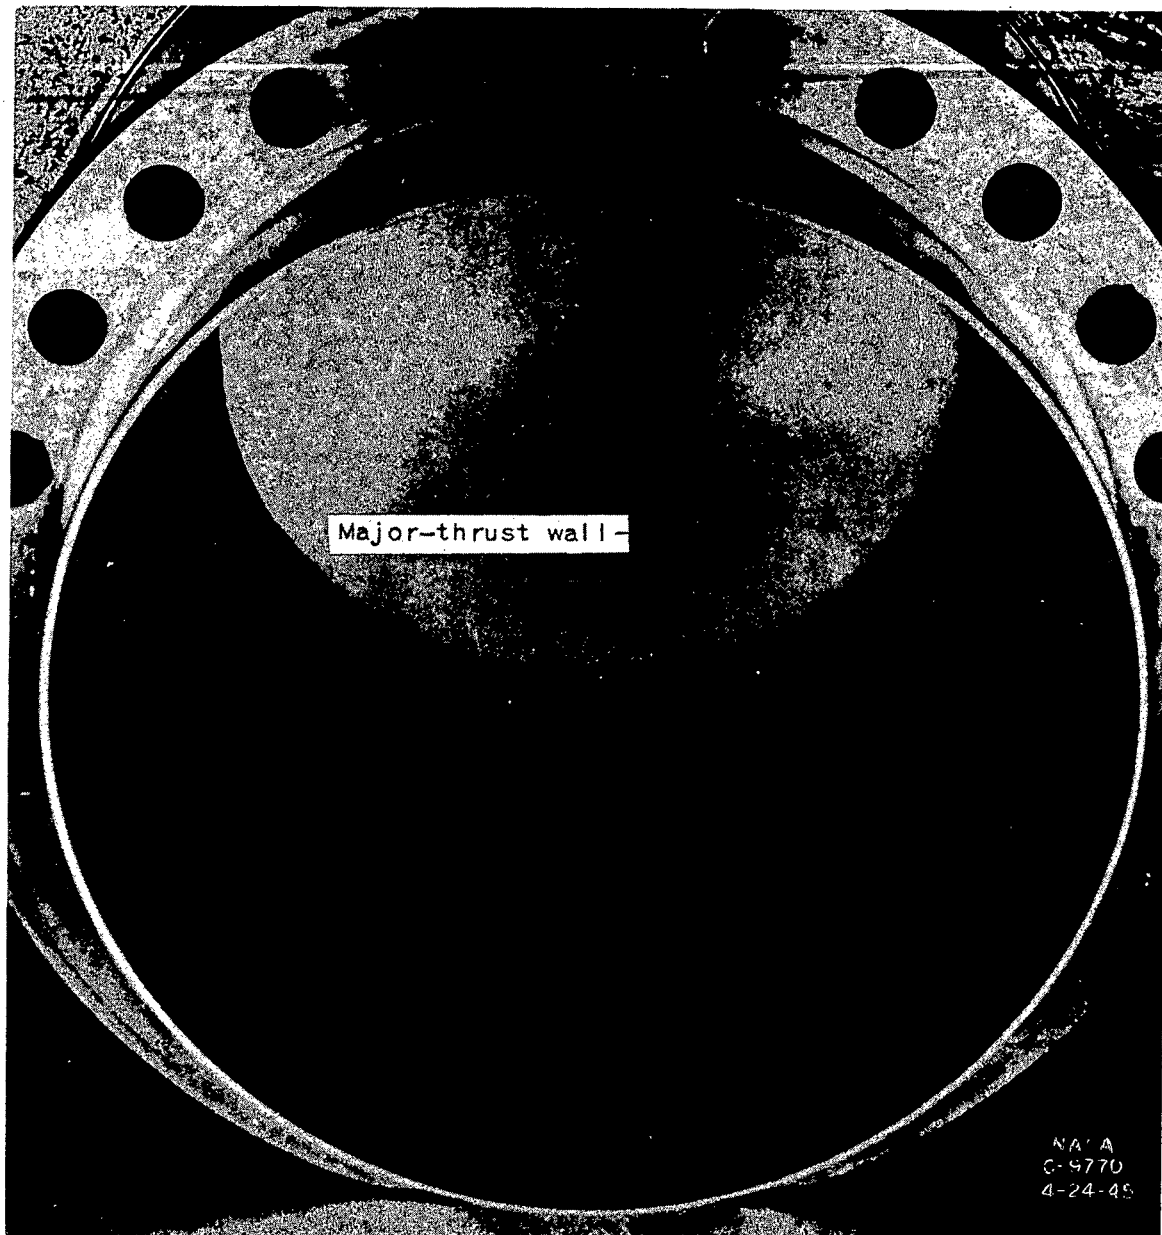
Figure 5. - Condition of bore of typical cylinder after 50-hour test of nine-cylinder air-cooled radial engine. Brake horsepower, 750; engine speed, 1900 rpm; brake mean effective pressure, 172 pounds per square inch; fuel-air ratio, 0.052; spark advance, 30° B.T.C.; maximum rear-spark-plug-bushing temperature, 400° F.

Cylinders. - Inspection of the cylinder components after engine disassembly indicated that they were in good condition. The cylinder barrels were in good condition. All the barrels were lightly lacquered and had a few light scuff marks on the major-thrust wall. The major-thrust wall of a typical cylinder barrel is shown in figure 5. The cylinder-bore wear in both the thrust and nonthrust directions resulting from the test is shown in table I. Cylinder wear, which was heaviest in the choke, was very light on the thrust and nonthrust diameters. The valve seats were in good condition. The cylinder domes had a light carbon coating with a few localized heavy-lead deposits (fig. 6). In the cylinder photographed, the localized-lead deposits were near the junction of the head and barrel between the front spark-plug bushing and the intake-valve seat insert. The localized-lead deposits in the rest of the cylinders were heavier and occurred near the junction of the head and barrel but in different places around the cylinder.

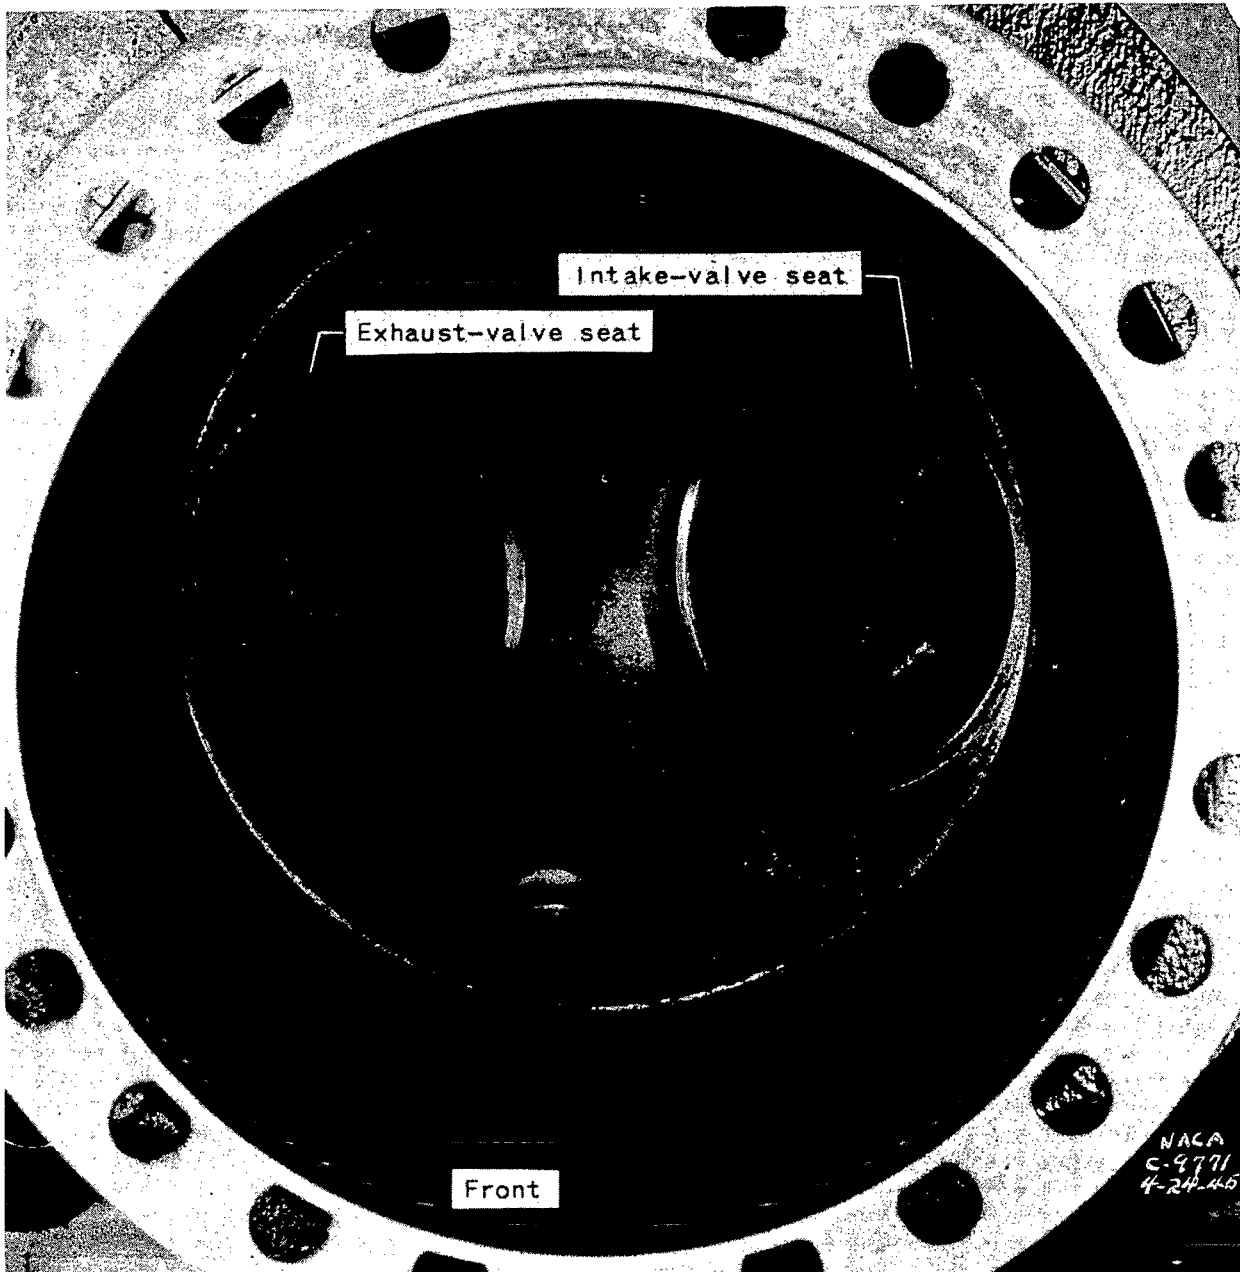
Figure 6. - Condition of combustion chamber of typical cylinder after 50-hour test of nine-cylinder air-cooled radial engine. Brake horsepower, 750; engine speed, 1900 rpm; brake mean effective pressure, 172 pounds per square inch; fuel-air ratio, 0.052; spark advance, 30° B.T.C.; maximum rear-spark-plug-bushing temperature, 400° F.

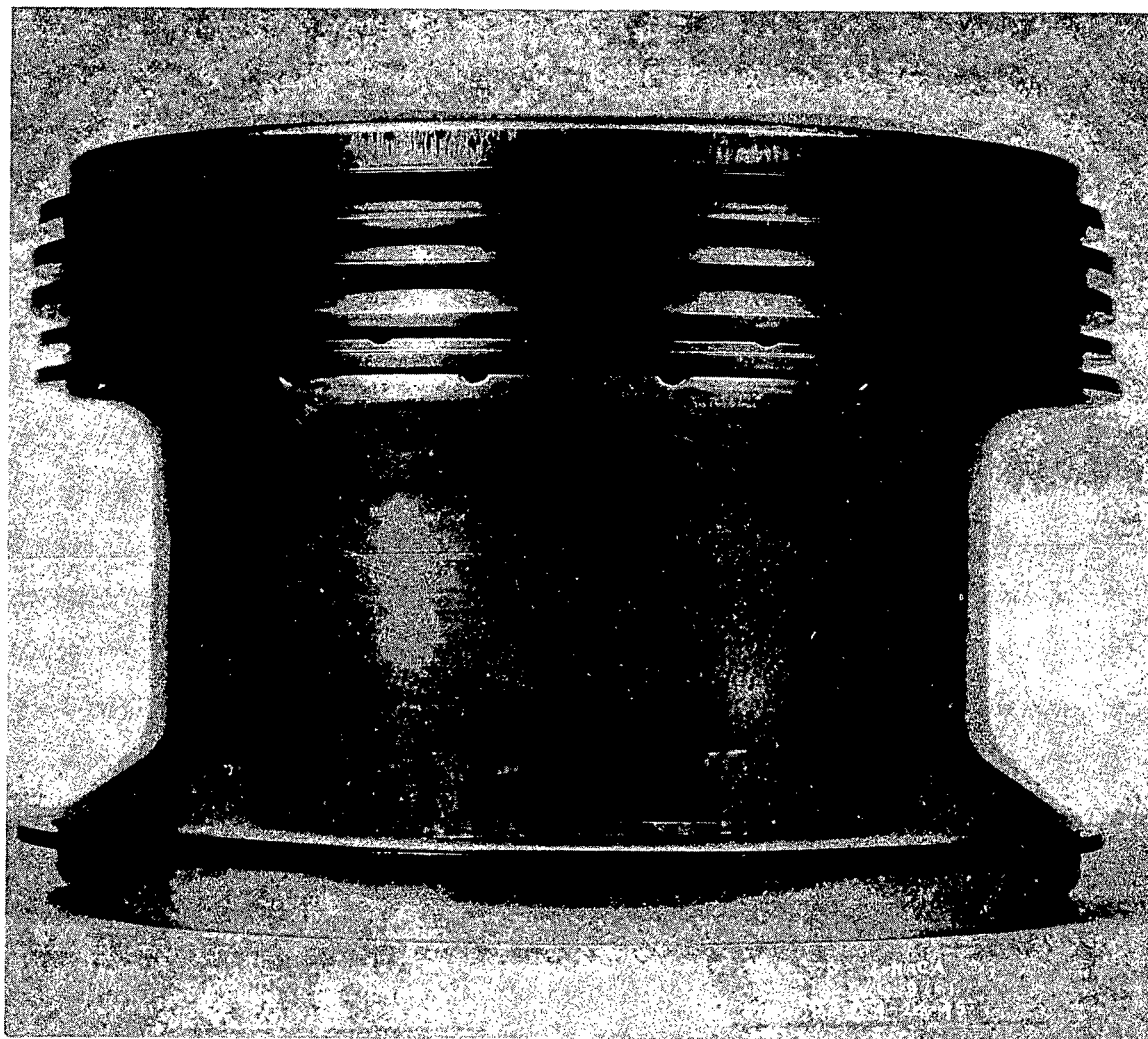
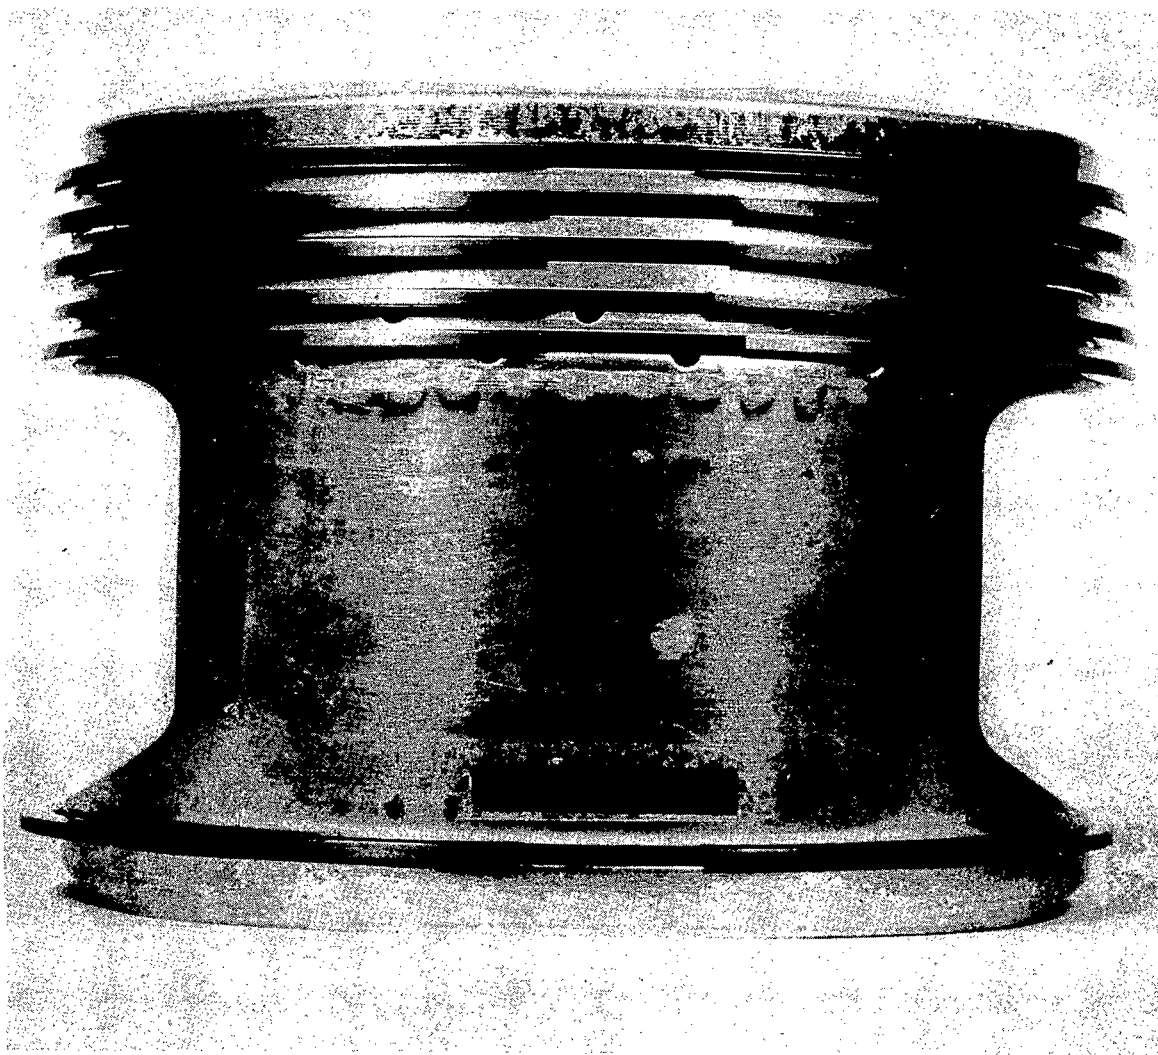
(a) Major thrust.

Figure 7. - Condition of typical piston and rings after cleaning following 50-hour test of nine-cylinder air-cooled radial engine. Brake horsepower, 750; engine speed, 1900 rpm; brake mean effective pressure, 172 pounds per square inch; fuel-air ratio, 0.052; spark advance, 30° B.T.C.; maximum rear-spark-plug-bushing temperature, 400° F.

(b) Minor thrust.

Pistons and piston rings. - The pistons were in very good condition at the end of the test. The piston crowns were covered with a light carbon deposit and small localized-lead deposits similar to those on the dome of the cylinders. The major-thrust and minor-thrust faces of a typical piston with rings after cleaning at the end of the test are shown in figure 7. These photographs show the light face contact at the top and bottom of the thrust faces and the light scuff marks on the piston thrust face. Piston wear resulting from the test was too small to measure. No pounding out of the ring lands existed as shown by the values of piston-ring side clearance in table II.

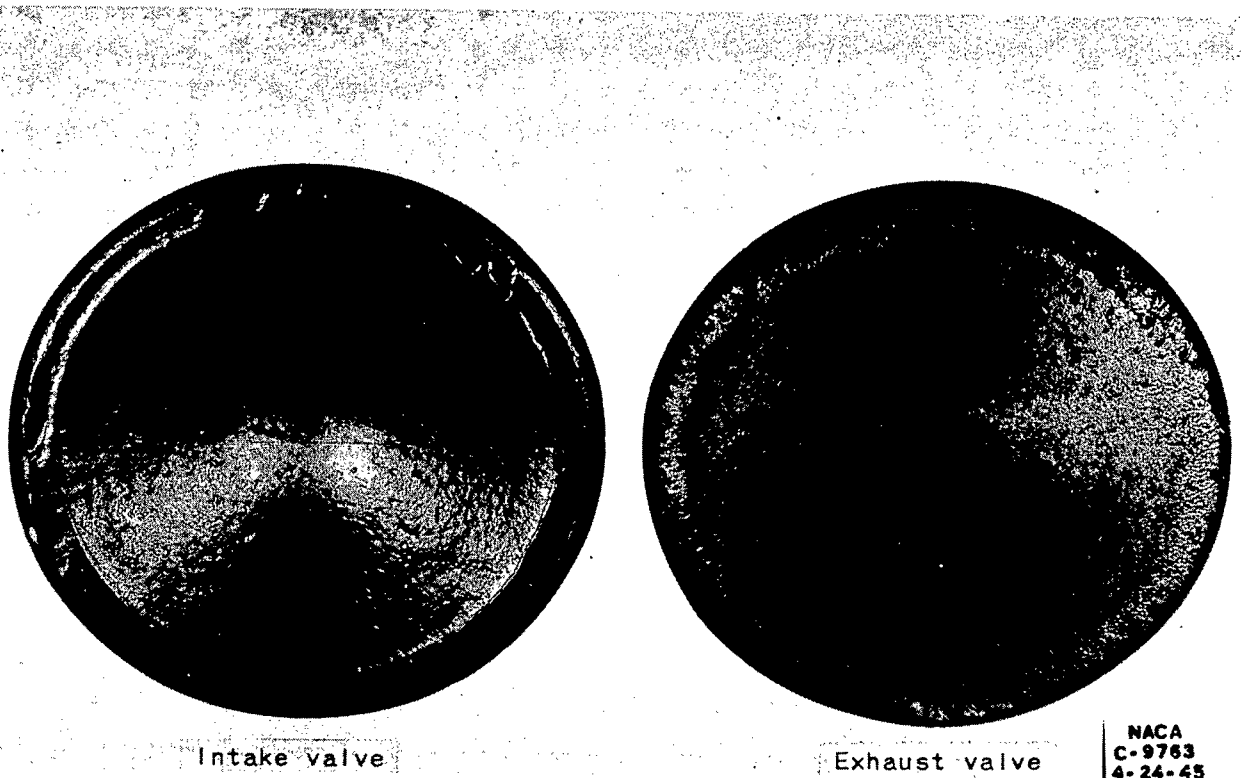
Figure 8. - Valve heads of cylinder 7 typical of intake and exhaust valves after 50-hour test of nine-cylinder air-cooled radial engine. Brake horsepower, 750; engine speed, 1900 rpm; brake mean effective pressure, 172 pounds per square inch; fuel-air ratio, 0.052; spark advance; 30° B.T.C.; maximum rear-spark-plug-bushing temperature, 400° F.

Valves. - All the valve heads were covered with a heavy deposit when they were removed from the engine. The typical heavy deposits on the heads of both the intake and exhaust valves are shown in figure 8. The deposits on the intake valves were greenish-yellow with a

glazed surface and completely covered the concave portion of the valve head. The coating on the exhaust valves varied from the smooth greenish-yellow deposits shown on the valve in figure 8 to the dark red globular deposits shown on the valve head in figure 9. The weight of the deposits on the valves is given in table III. The average weight of deposit was 4.15 and 7.26 grams for the exhaust and intake valves, respectively.

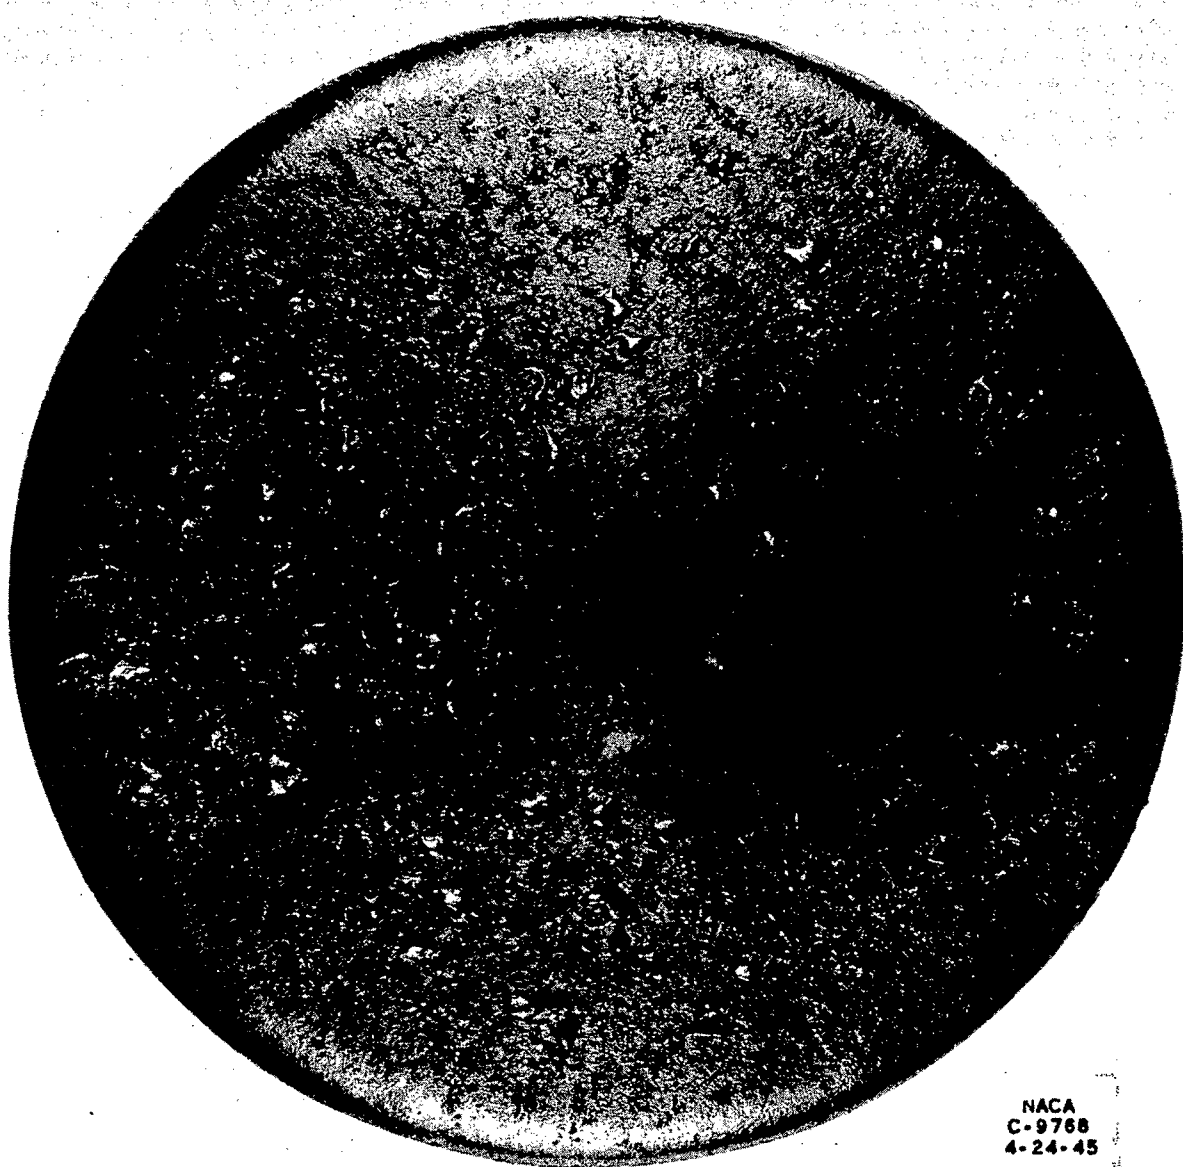
Figure 9. - Condition of exhaust-valve head from cylinder 9 after 50-hour test in nine-cylinder air-cooled radial engine. Brake horsepower, 750; engine speed, 1900 rpm; brake mean effective pressure, 172 pounds per square inch; fuel-air ratio, 0.052; spark advance, 30° B.T.C.; maximum rear-spark-plug-bushing temperature, 400° F.

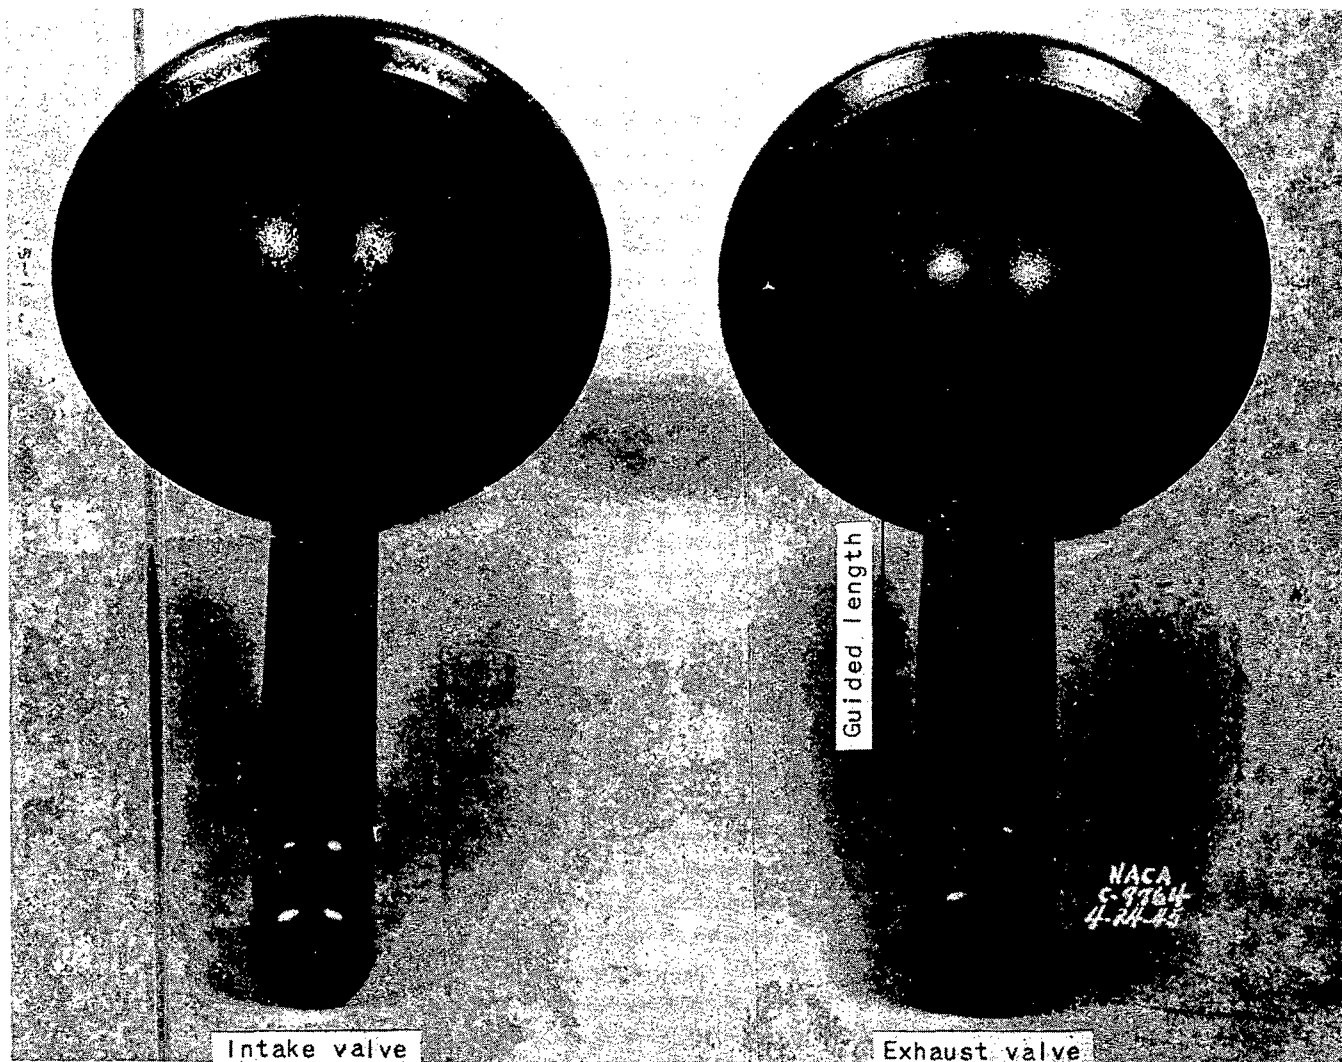
Figure 10. - Condition of valve stems and necks from cylinder 7 typical of intake and exhaust valves after 50-hour test in nine-cylinder air-cooled radial engine. Brake horsepower, 750; engine speed, 1900 rpm; brake mean effective pressure, 172 pounds per square inch; fuel-air ratio, 0.052; spark advance, 30° B.T.C.; maximum rear-spark-plug-bushing temperature, 400° F.

The stems and seating faces of a typical intake and exhaust valve after removal from the engine are shown in figure 10. An examination of the valves after cleaning showed that all of the exhaust-valve faces were in good condition with the exception of the valve from cylinder 9, which was lightly burned in one spot. The burn was very shallow and before cleaning was filled with a hard deposit so that the valve face formed an unbroken seal and the mating seat showed no evidence of burning. It is therefore improbable that the light valve-face burning would progress further. The lightly burned portion of the exhaust-valve face of cylinder 9 after the deposits had been removed is shown in figure 11.

Heavy carbon and lead-oxide deposits and light bronze pickup from the exhaust-valve guide were present for one-half inch at the head end of the exhaust-valve stem guided length. All the exhaust-valve guides were worn to a bellmouth beyond the Army limits stated in reference 10. Three of the valve guides were worn beyond the manufacturer's bellmouth limit (reference 11), which is less severe

than the Army's limit. The bellmouthing of the exhaust-valve guides is believed to have been a result of heavy carbon and lead-oxide deposits on the head end of the valve stem. All the intake-valve faces were in excellent condition. Light soft carbon deposits were present on the under side of the intake-valve heads (fig. 10). The intake-valve stems were in excellent condition and the intake-valve guides were not excessively worn. No indication of valve sticking as a result of the heavy stem deposits was evident at any time during the test.

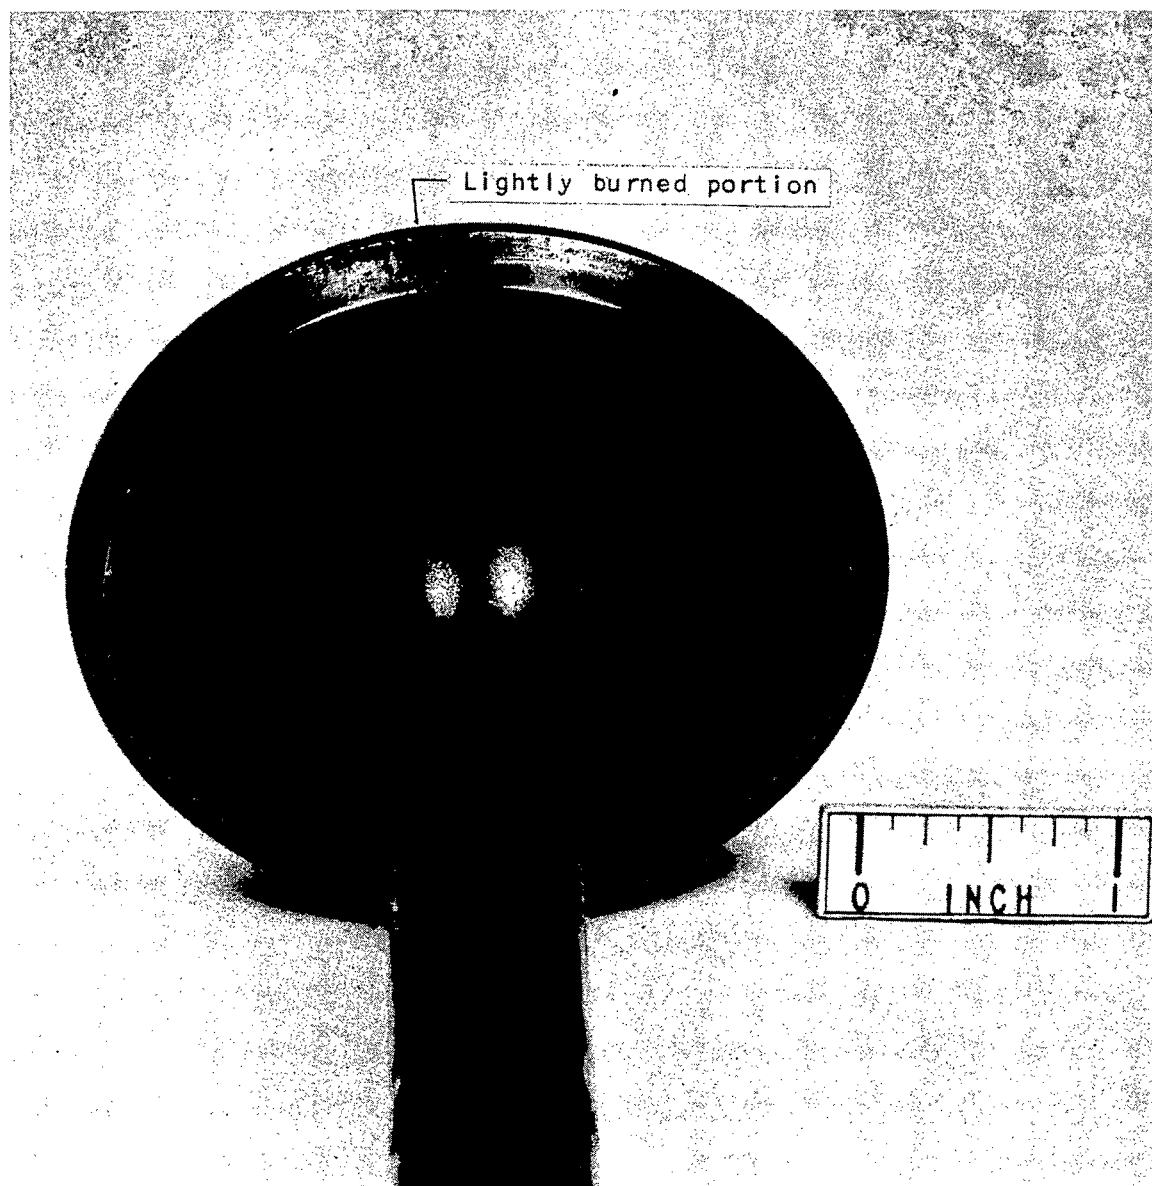
Figure 11. - Condition of exhaust-valve face from cylinder 9 after 50-hour test in nine-cylinder air-cooled radial engine. Brake horsepower, 750; engine speed, 1900 rpm; brake mean effective pressure, 172 pounds per square inch; fuel-air ratio, 0.052; spark advance, 30° B.T.C.; maximum rear-spark-plug-bushing temperature, 400° F.

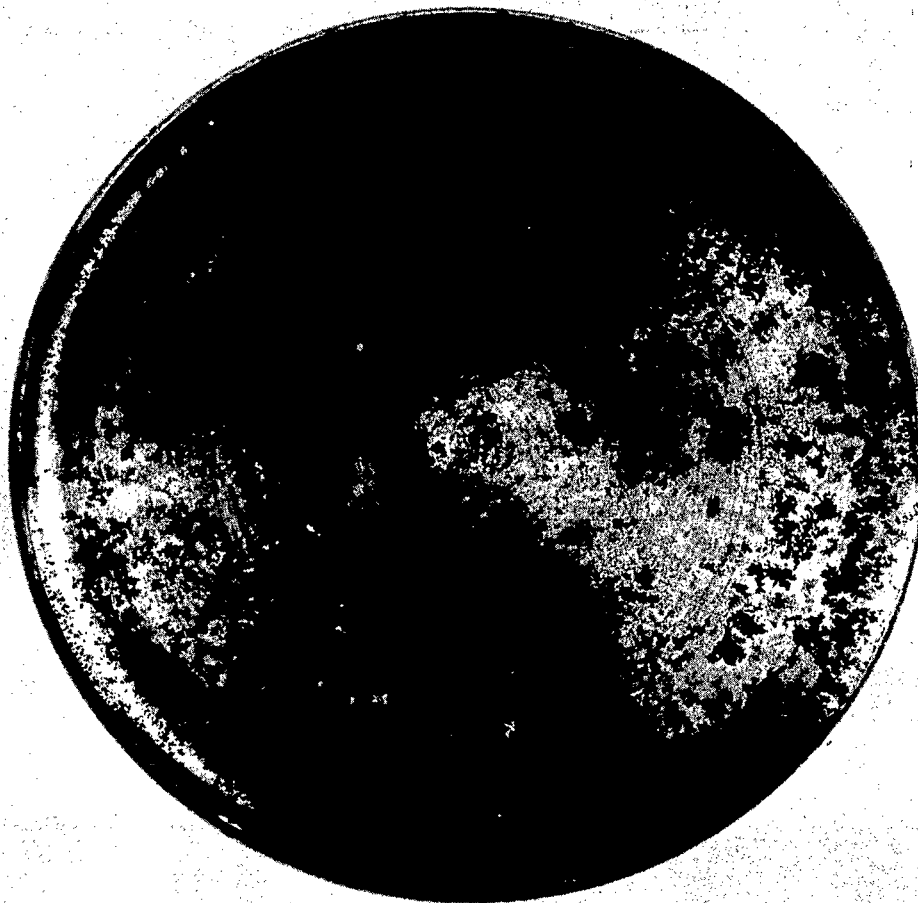
Figure 12. - Condition of exhaust-valve crown from cylinder 9 after cleaning following 50-hour test in nine-cylinder air-cooled radial engine. Brake horsepower, 750; engine speed, 1900 rpm; brake mean effective pressure, 172 pounds per square inch; fuel-air ratio, 0.052; spark advance, 30° B.T.C.; maximum rear-spark-plug-bushing temperature, 400° F.

All of the valves, except two sets, were cleaned by the electrolytic method of reference 12. The deposits were not removed from these two sets of valves pending further investigation of the deposits. Of the valves cleaned, the crowns of two were in excellent condition, four had numerous "pin-point" pit marks, and one was severely pitted as shown in figure 12. Some of the intake valves had a few very small scattered pin-point pits. (See table III.)

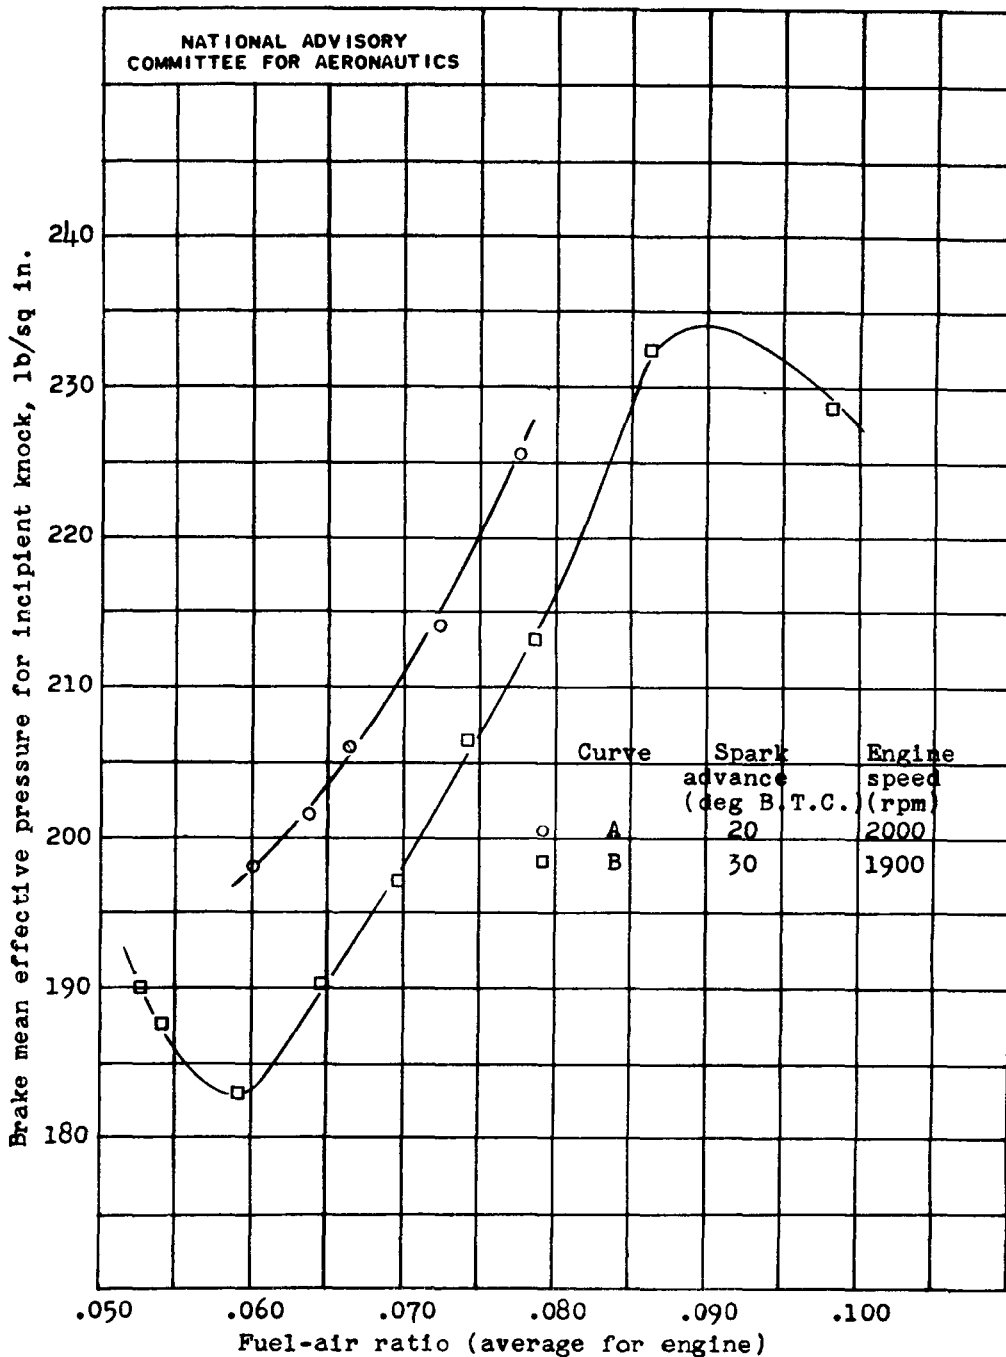
Figure 13. - Maximum brake mean effective pressure as limited by incipient knock, for two conditions of speed and spark advance obtained from tests of nine-cylinder air-cooled radial engine. Carburetor-air temperature, 100° F; maximum rear-spark-plug-bushing temperature, 500° F; fuel, AN-F-28, Amendment-2.

For this engine, the maximum brake mean effective pressure as limited by incipient knock was approximately 15 percent lower for the conditions of this test (fuel-air ratio, 0.052; spark advance, 30° B.T.C.; and engine speed, 1900 rpm) than for those recommended by the Army (fuel-air ratio, 0.076; spark advance, 20° B.T.C.; and engine speed, 2000 rpm). (See fig. 13.)

As shown in figure 13, the knock-limited brake mean effective pressure at a fuel-air ratio of 0.052, spark advance of 30° B.T.C., and engine speed of 1900 rpm, and at a maximum rear-spark-plug-bushing temperature of 500° F was 192 pounds per square inch. Therefore, operation of this engine at 750 brake horsepower at the conditions of this test should allow a margin of safety on the brake mean effective pressure for incipient knock of approximately 12 percent if the higher cylinder temperature allowed during the running of the knock curves were neglected. Although no attempt will be made to correct the margin of safety for the 100° F difference in maximum cylinder-head temperature, it should be pointed out that an increase in cylinder-head temperature will decrease the knock-limited brake mean effective pressure a considerable amount at low fuel-air

ratios (reference 14). Therefore, the actual margin of safety for incipient knock for a maximum rear-spark-plug-bushing temperature of 400° F should be considerably higher than the 12 percent indicated on figure 13.
